Wamble & Associates, Pllc
Civil Engineering • Land Surveying • Land Planning

May 18, 2010

Re: Devon Glen – Phases 1, 2 and 3
Devon Valley – Phases 1 and 2
Devon Highlands – Phase 1 (Devon Highlands North)
Devon Highlands – Phase 2 (Devon Highlands South)

I am writing this letter to report my recommendations for the clean-up and maintenance of drainage facilities in the above referenced communities that were overwhelmed by the rainfall event on May 2, 2010. This work is based on my site visit and inspection of the drainage facilities on May 6, 2010.

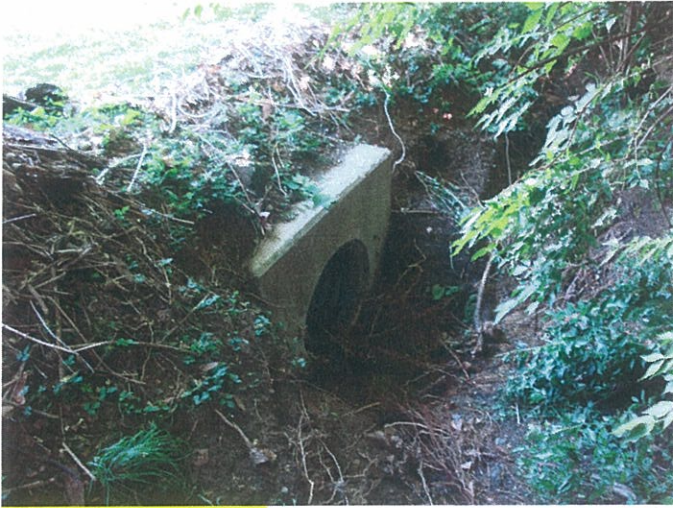
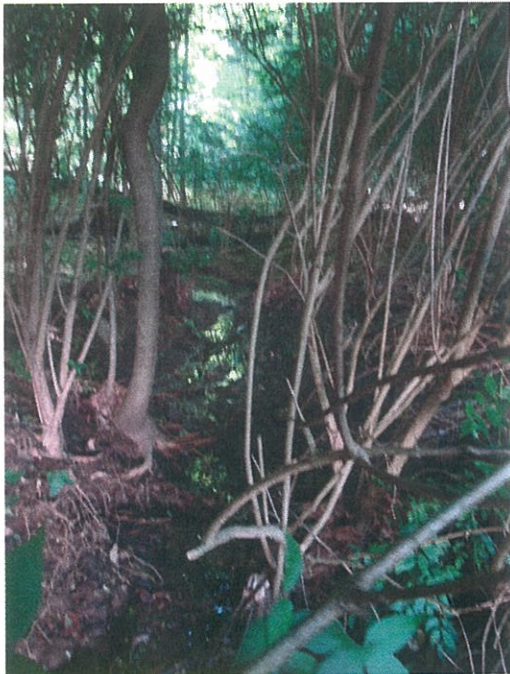
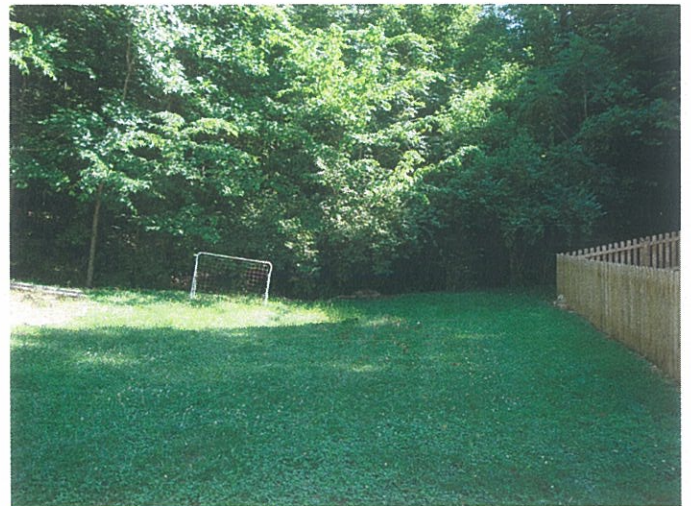
Behind the house, in the right rear corner of the yard, there is an existing concrete headwall with a drainage pipe that had been overtopped by runoff from the rainfall event on May 2, 2010. Photo 2580 shows the headwall; photo 2581 shows the upland wooded drainage area that flows down to the headwall; photo 2582 shows the right rear corner of the yard behind the headwall. Besides the obvious task of cleaning out the pipe and removing the debris that has accumulated, the following work should be performed:

- Excavate soil to create a pond-like area in front of the headwall to provide additional storage for stormwater runoff until the pipe can receive and convey the water through the underground storm sewer system.
- Place the excavated soil on top of and behind the headwall to create a higher berm along the edge of the yard. This will allow the runoff to stand at a deeper depth and will result in an increase in the amount of stormwater that will flow into and through the pipe.
- The new berm area should be stabilized with vegetative ground cover or erosion control matting to prevent any erosion during and after construction. To stabilize the excavated storage area in front of the headwall, use rip-rap placed over a geotextile fabric.

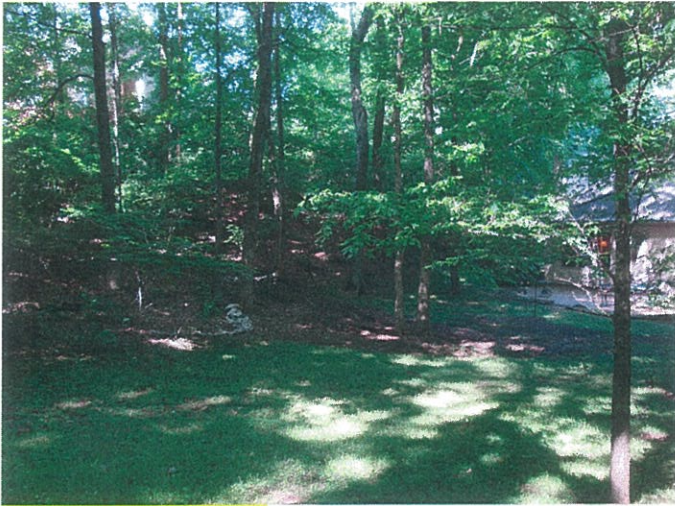
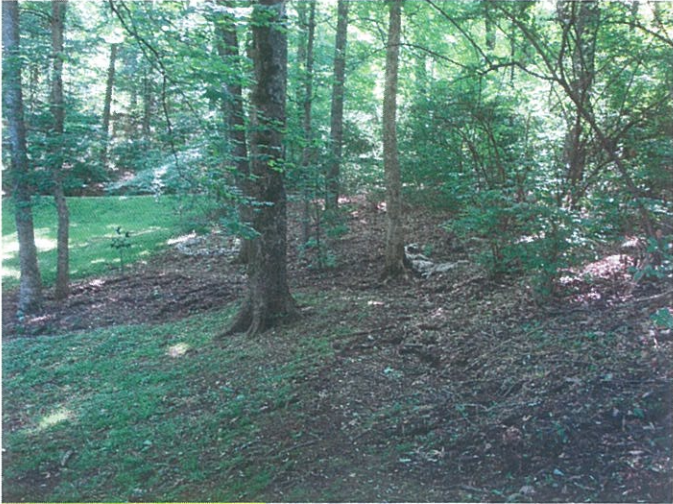
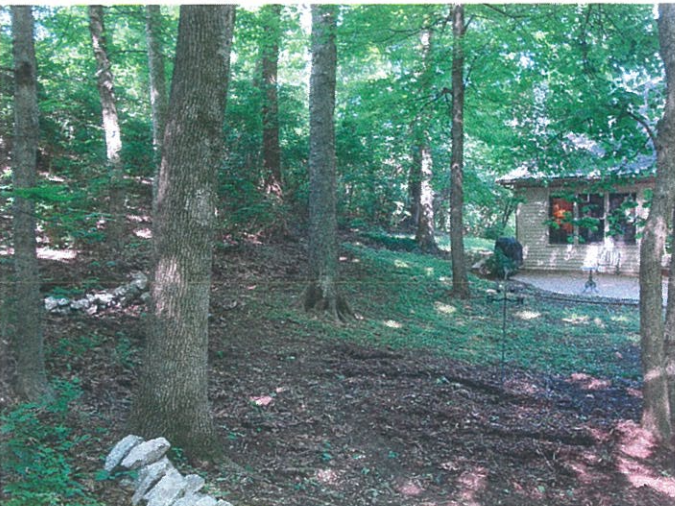
A fairly large wooded area with heavy tree cover on the adjacent property drains down into the backyard of this property. The backyard of the property is shown in photos 2585, 2588, and 2589. These photos show that the homeowner has constructed several small rock check dams in an attempt to slow down the flow of stormwater and stop erosion of their landscaped beds. Once the water comes down into the backyard, it flows around the side of the house, which is shown in photos 2587 and 2591. The adjacent lot at 2420 Devon Valley Drive has a drainage ditch in the rear that catches the upland runoff and conveys it to a headwall that is located two lots to the left. However, this ditch is too far up the hill to extend to provide any benefit. I recommend the following:

- Starting in the right side yard near the front of the house where there is an existing small drainage ditch, construct a larger drainage ditch all the way around the rear of the house and across the backyard. Place the excavated soil on the downhill side of the ditch to create a gently sloping berm that will catch and convey a larger quantity of stormwater. This drainage ditch will terminate in the front yard and the water will spread out into the front yard, spill over the curb, and drain into the gutter on the street. As this drainage ditch is constructed into the backyard, it should be placed in a location that is continuously sloping upward so that there is positive grade to convey the water from the backyard to the front yard. This may require it to go across the property line. If so, easements should be worked out with the adjacent property owner. This ditch should terminate at the point where it has wrapped all the way around the backyard and will intercept, catch, and convey the upland stormwater to the street.

- All the area that is disturbed and re-graded with the construction of this ditch should be stabilized with vegetative ground cover or erosion control matting.

- During construction of this ditch, an engineer should be employed to inspect and determine if vegetative ground cover in this shaded area will be able to be established to control erosion. If not, this ditch may have to be lined with geotextile fabric and rip-rap in order to stabilize it.

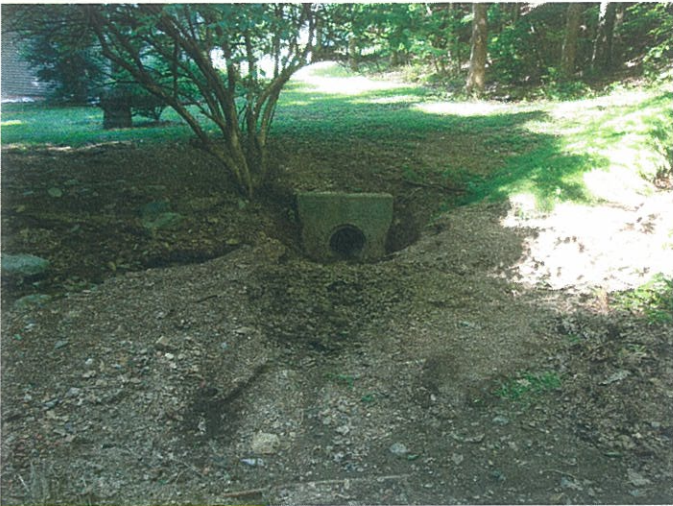
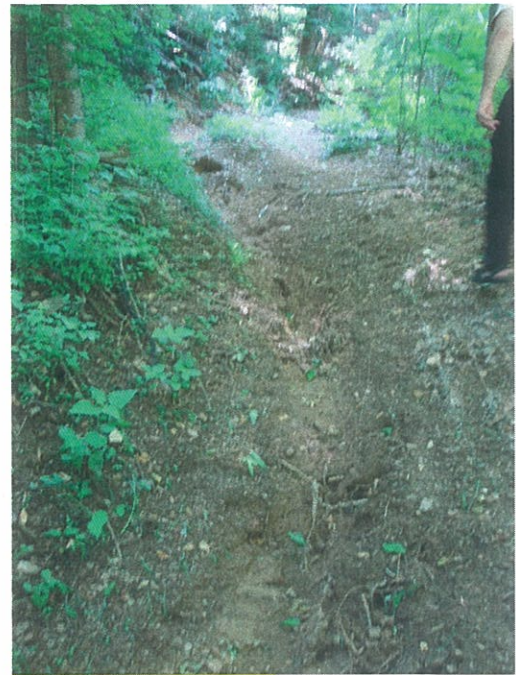
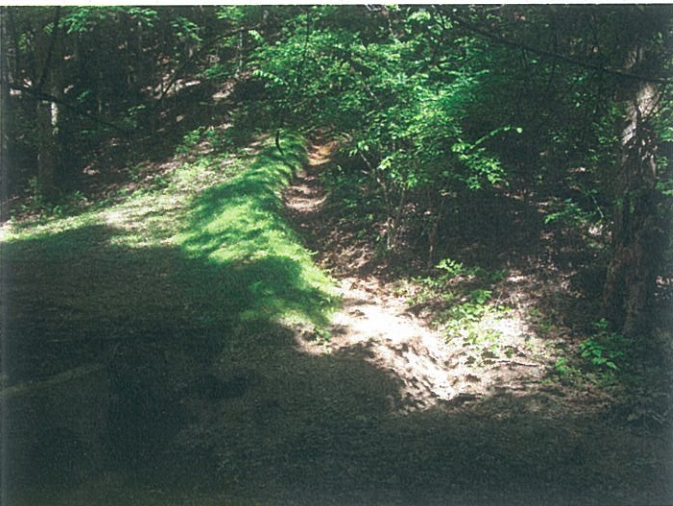
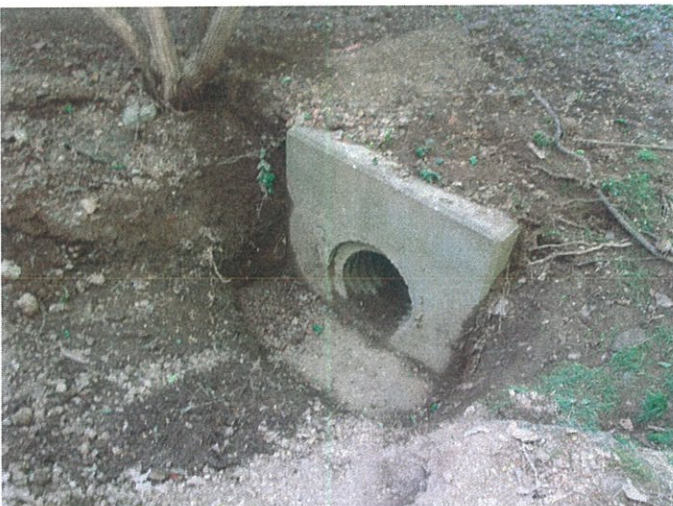
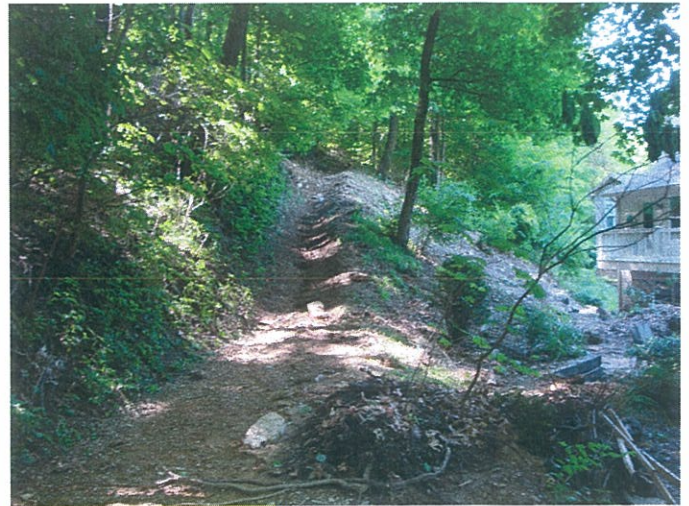
Behind this house, there's a large, steep valley that drains down to a headwall and pipe that is shown in photos 2597 and 2600. The area that drains to the headwall from the west is shown in photo 2598. Photos 2604 and 2607 show the area that drains from the east down to this headwall. We recommend the following work:

- Excavate soil to create a pond-like area in front of the headwall to provide additional storage for stormwater runoff until the pipe can receive and convey the water through the underground storm sewer system.
- Place the excavated soil on top of and behind the headwall to create a higher berm which will allow the water to stand at a greater depth before it can spill over into the yard and then flow across the yard towards the back of the house.
- Stabilize the berm area with vegetative ground cover or erosion control matting.
- Stabilize the excavated storage area in front of the headwall with rip-rap placed over a geotextile fabric.

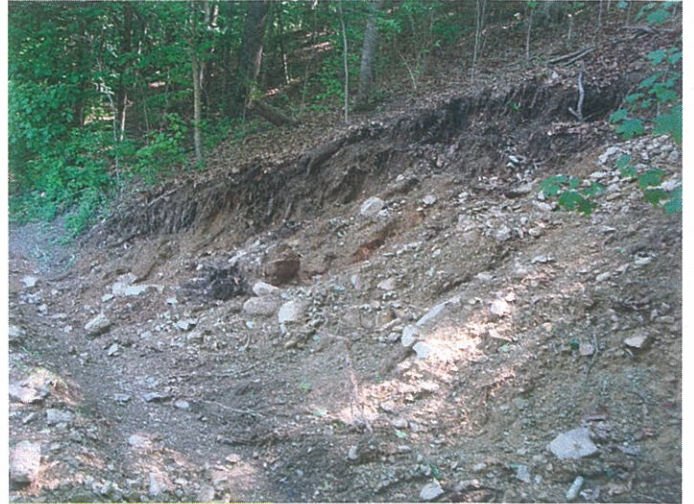
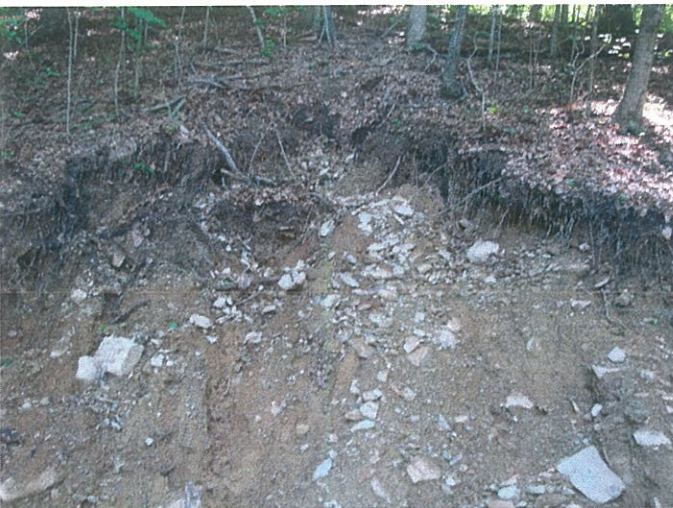
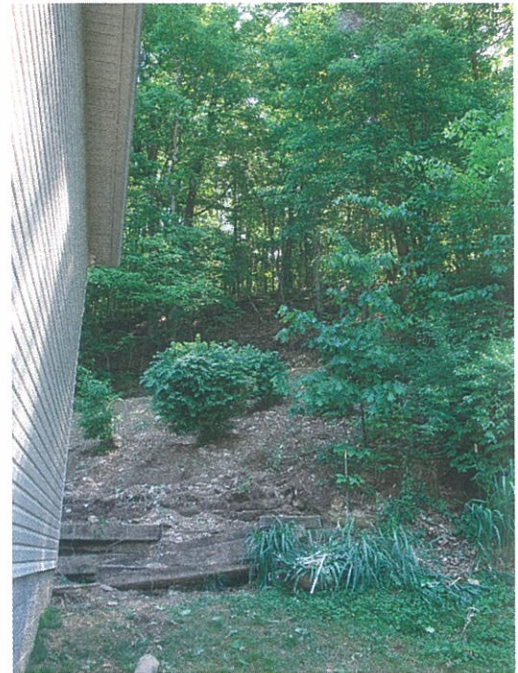
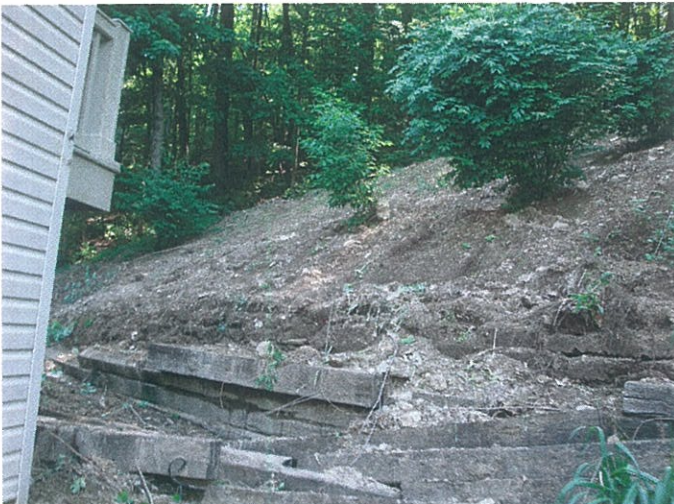
Behind this house, the land slopes steeply upward. A portion of this slope area failed and slid down to the back of this house as is shown in photos 2616 and 2618. When this slope failed, a series of cross-tie retaining walls in the backyard of this house were pushed down as can be seen in photos 2622 and 2623. A tree also slid down the hill and onto the back patio of the house as is shown in photos 2621, 2614, and 2613. The sloping nature of the backyard of this house is shown in photos 2607, 2612, 2615, and 2619. Photos 2608 and 2609 show an existing tree, with a large portion of its canopy curving toward the house. This tree did not slide, however, I recommend that the portion of the tree that is leaning toward the house be removed by an arborist or tree trimming service. I also recommend the following:

- Remove the portion of the tree that is leaning toward the house.
- For the unstable failed slope area, contact GEC at (615) 599-9660 and speak to K. Michael Garmon about retaining them to advise you of your options in stabilizing this slope area for future large rainfall events. I am sending a copy of this letter to GEC for their review.

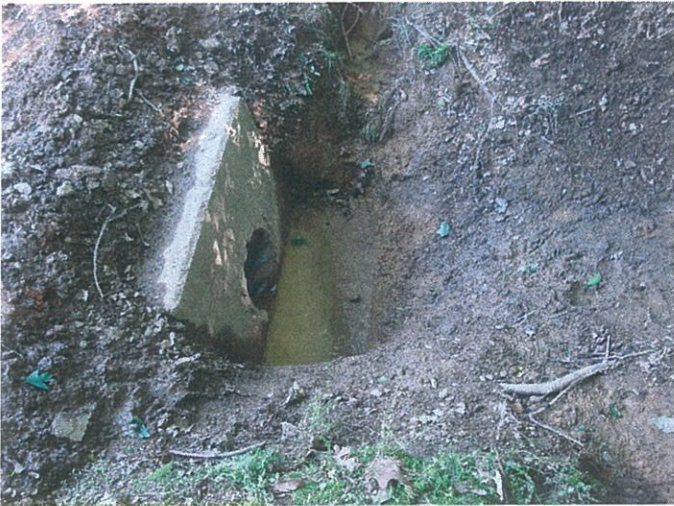
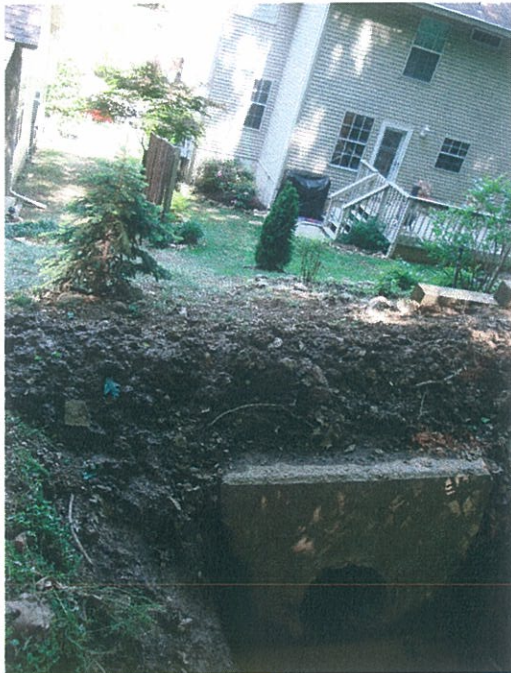
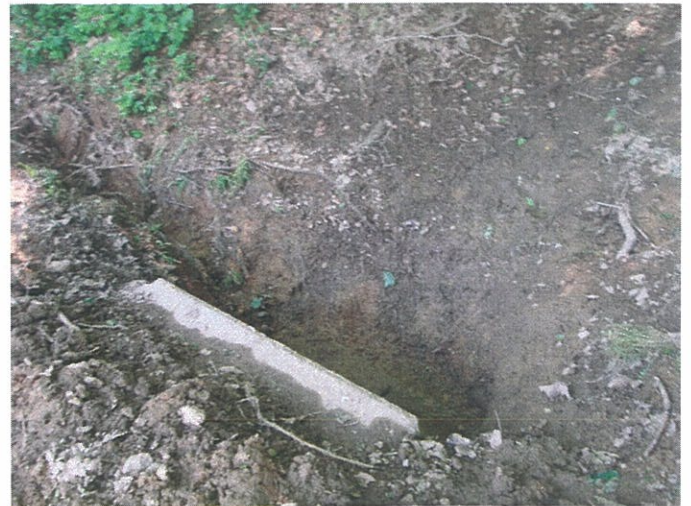
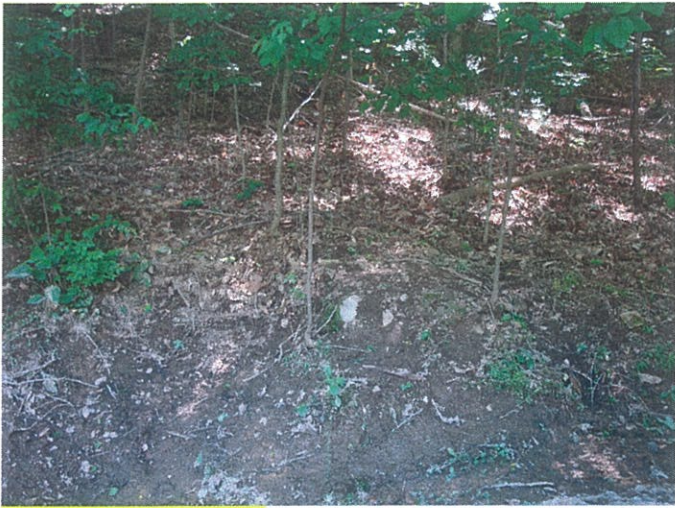
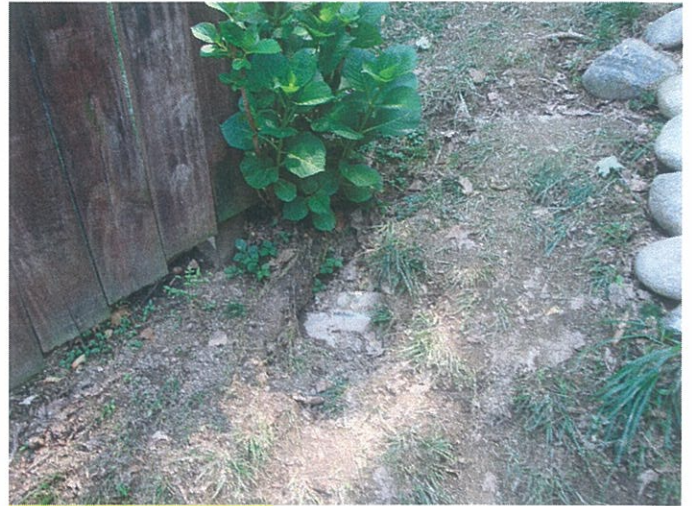
There is a headwall and pipe that collects drainage from an upward sloping area behind the house. The headwall is shown in photos 2634, 2633, and 2638. The area of the pipe that runs from the headwall to the street is exposed in the side yard, as shown in photo 2642, and erosion caused by the overflow of this headwall is shown in 2643. The side yard of the house, looking down from the headwall, is shown in photos 2640 and 2641. A drainage ditch behind the lots to the north, coming down to this headwall, is shown in photo 2636, and the drainage area behind this house to the east is shown in photo 2639. We recommend the following:

- Excavate soil to create a pond-like area in front of the headwall to provide additional storage for stormwater runoff until the pipe can receive and convey the water through the underground storm sewer system.
- Place the excavated soil on top of and behind the headwall to create a higher berm along the edge of the yard. This will allow the runoff to stand at a deeper depth and will result in an increase in the amount of stormwater that will flow into and through the pipe.
- The new berm area should be stabilized with vegetative ground cover or erosion control matting to prevent any erosion during and after construction. To stabilize the excavated storage area in front of the headwall, use rip-rap placed over a geotextile fabric.
- Repair the erosion area. Cover the exposed pipe with topsoil in the side yard and stabilize the vegetative ground cover.

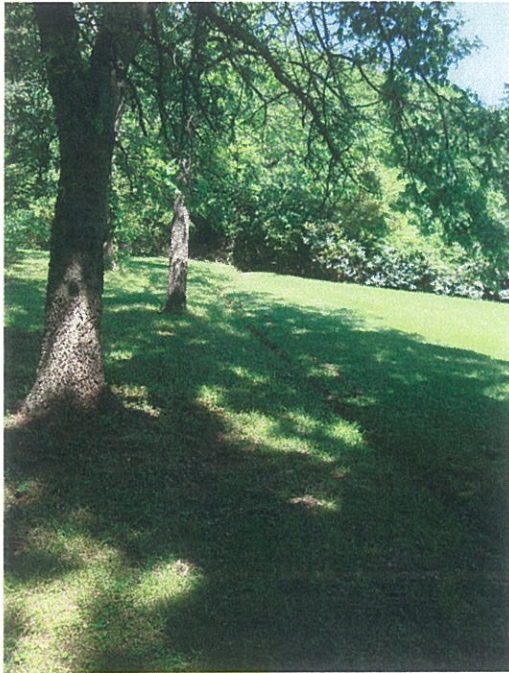
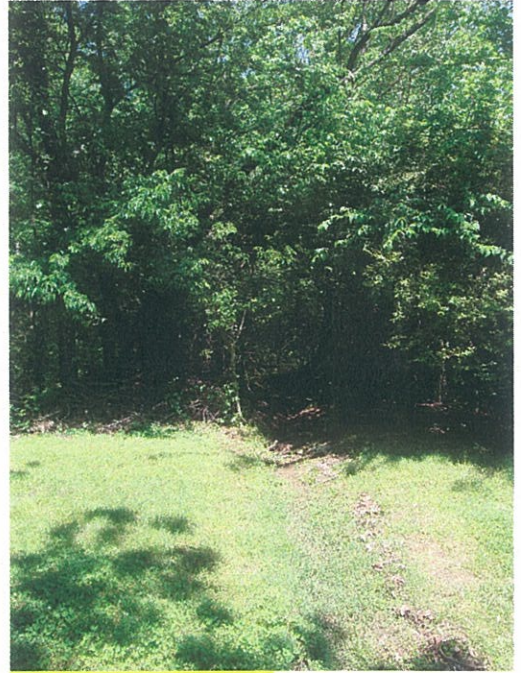
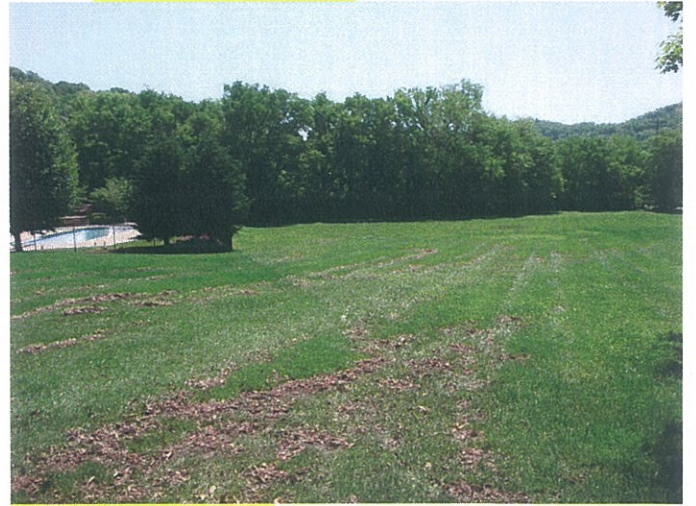
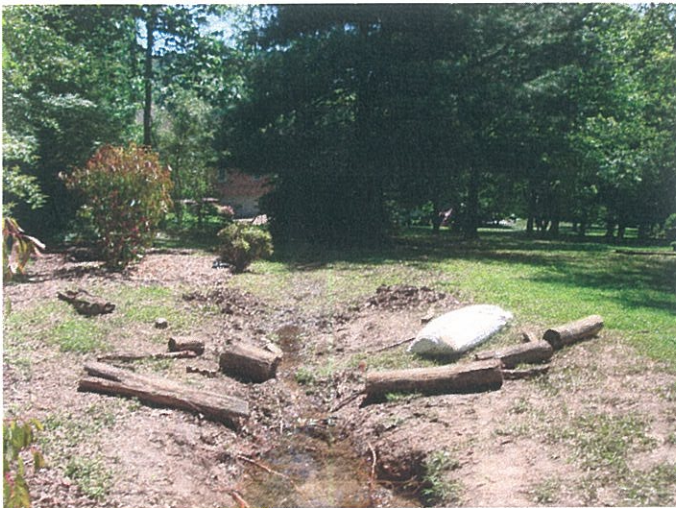
The backyard of this house was covered with stormwater that flowed from the drainage that is located to the northwest of the house. There was a small drainage ditch behind the house which is shown in photos 2647 and 2651. Water flowed southeast, across the backyards of several houses in this area, washing debris and mulch from the landscaping areas as shown in photos 2657 and 2653. The area that drains from the southeast into this backyard flows through a drainage ditch across the adjacent property shown in photo 2650. We recommend the following:

- In the location of the existing small drainage ditch near the rear property line, starting where it enters the woods (photo 2651), construct a ditch and place the excavated soil on the lower side that slopes downward, creating a berm to provide more depth and capacity to increase its ability to convey stormwater. This ditch should be a minimum of four feet wide and about 18 inches deep, if it's possible to construct without encountering rock. The berm on the downhill side should be sloped 3-to-1 to allow easy maintenance and mowing.

- The downhill berm side should be stabilized with vegetative ground cover or erosion control matting.
- The excavated ditch should be stabilized with vegetative ground cover or erosion control matting. If grass won't grow in this shaded area, stabilize rip-rap placed over geotextile fabric.

- Terminate the ditch and berm in the area adjacent to the pool which is shown in photo 2653.

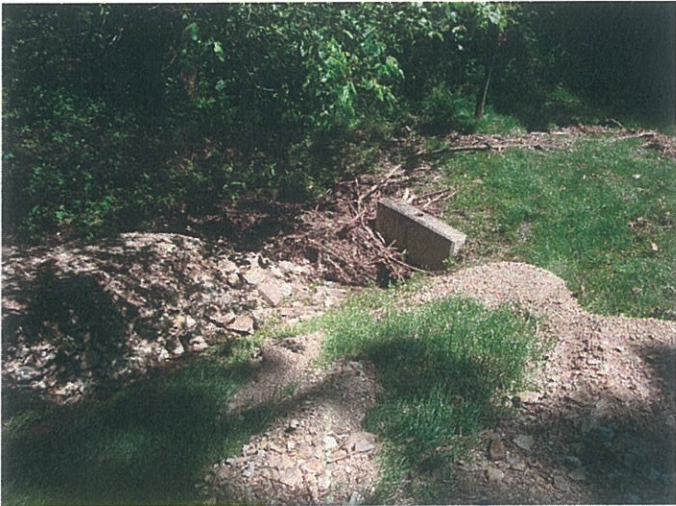
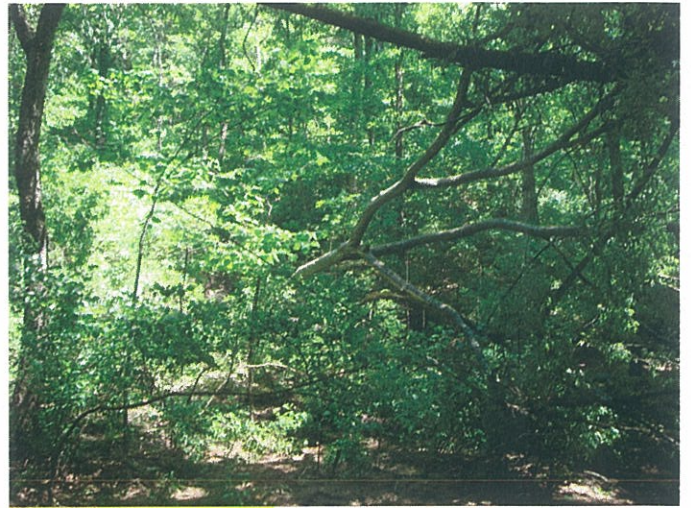
A fairly large hillside drains from the west, down to a headwall behind this house. The headwall is shown in photo 2661; the upland drainage area is shown in photo 2667. We recommend the following:

- Clean the debris away from the front of the headwall to allow it to receive drainage.
- Excavate soil to create a pond-like area in front of the headwall to provide additional storage for stormwater runoff until the pipe can receive and convey the water through the underground storm sewer system.

- Place the excavated soil on top of and behind the headwall to create a higher berm along the edge of the yard. This will allow the runoff to stand at a deeper depth and will result in an increase in the amount of stormwater that will flow into and through the pipe.

- The new berm area should be stabilized with vegetative ground cover or erosion control matting to prevent any erosion during and after construction. To stabilize the excavated storage area in front of the headwall, use rip-rap placed over a geotextile fabric.

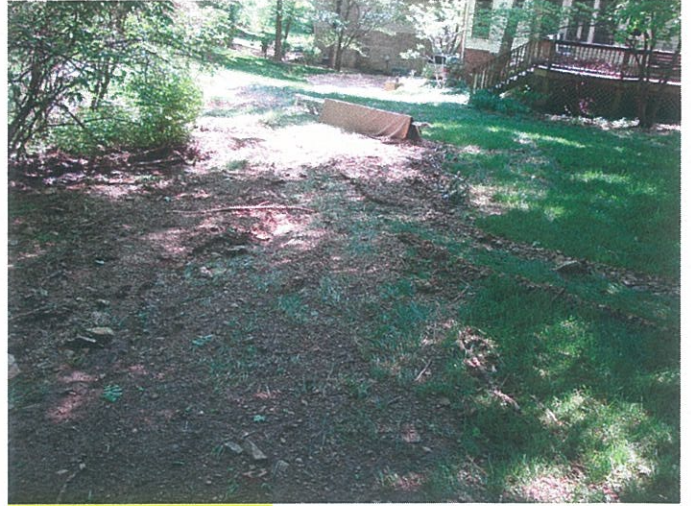
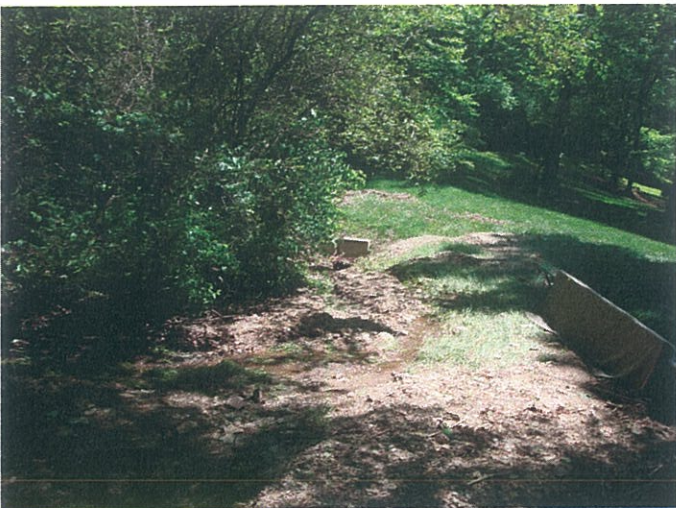
- Stormwater that drains from the southwest flows to this headwall but bypasses the headwall as shown in photos 2664 and 2665. As seen in these photos, the homeowner had placed wood to direct water to the headwall. A small diversion ditch should be constructed from the headwall southward, in a location that will allow the ditch to intercept the flow and direct it into the headwall storage area so that it will be caught by the storm sewer system. This diversion ditch should be approximately four feet wide and one foot deep with the excavated materials being placed on the downhill side at no greater than 3-to-1 slopes to create a small berm to help divert the stormwater runoff. The ditch and berm areas should be stabilized with vegetative ground cover or erosion control matting.

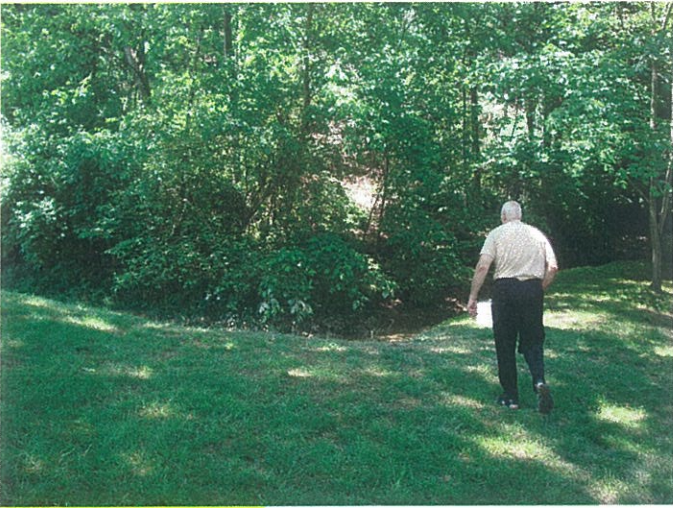
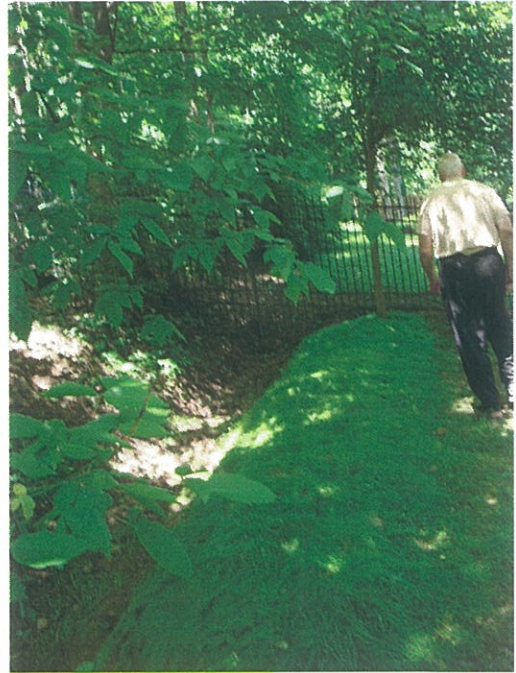
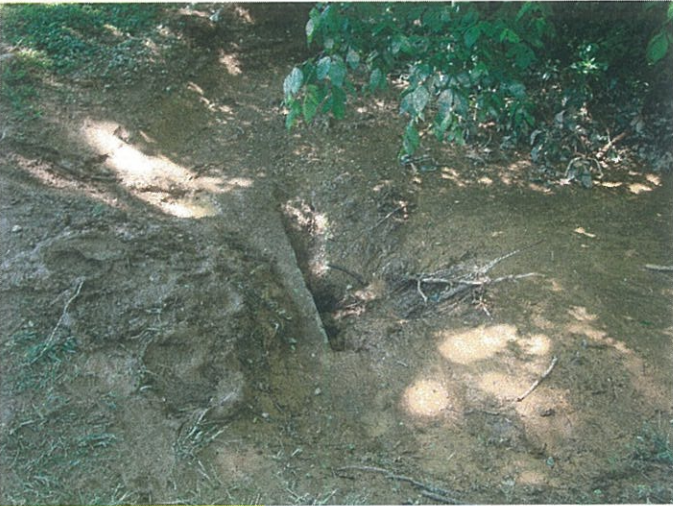
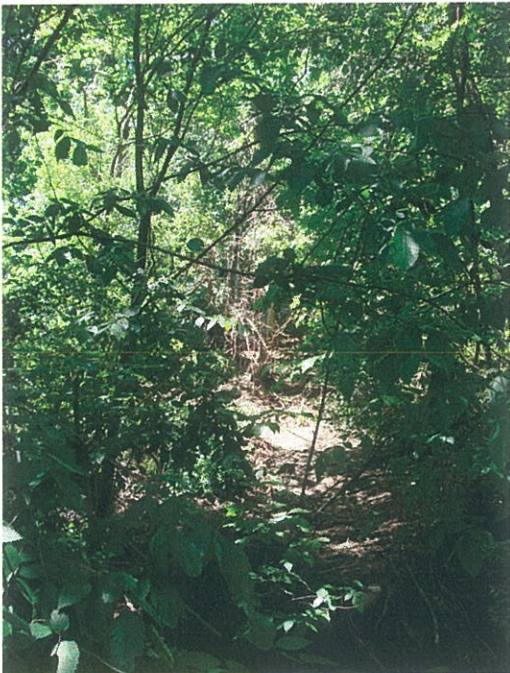
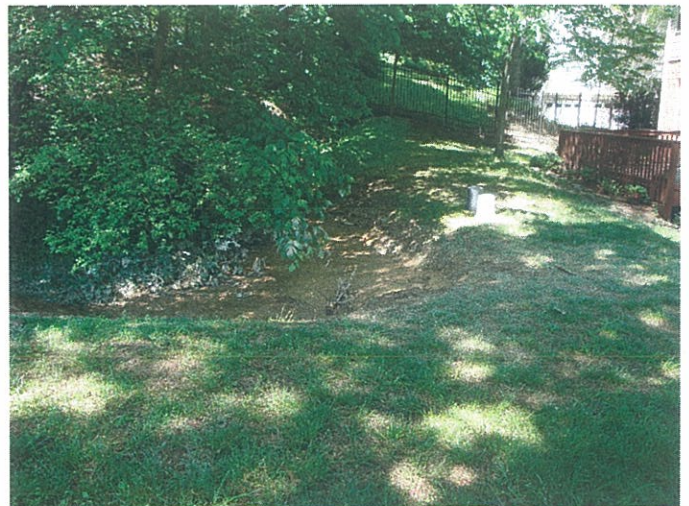
There was a headwall that had been completely silted in, as shown in photo 2674. This headwall is supposed to receive drainage from an upland sloped area located to the

southwest, which is shown in photos 2673 and 2675. An area that flows in from the west was flowing down through a ditch which is shown in photos 2676 and 2680. We recommend the following:

- Clean out all silt and debris from in front of headwall.
- Excavate soil to create a pond-like area in front of the headwall to provide additional storage for stormwater runoff until the pipe can receive and convey the water through the underground storm sewer system.
- Place the excavated soil on top of and behind the headwall to create a higher berm along the edge of the yard. This will allow the runoff to stand at a deeper depth and will result in an increase in the amount of stormwater that will flow into and through the pipe.
- The new berm area should be stabilized with vegetative ground cover or erosion control matting to prevent any erosion during and after construction. To stabilize the excavated storage area in front of the headwall, use rip-rap placed over a geotextile fabric.
