Wamble & Associates, Pllc
Civil Engineering • Land Surveying • Land Planning

May 18, 2010

Re: Devon Glen – Phases 1, 2 and 3
Devon Valley – Phases 1 and 2
Devon Highlands – Phase 1 (Devon Highlands North)
Devon Highlands – Phase 2 (Devon Highlands South)

I am writing this letter to report my recommendations for the clean-up and maintenance of drainage facilities in the above referenced communities that were overwhelmed by the rainfall event on May 2, 2010. This work is based on my site visit and inspection of the drainage facilities on May 6, 2010.

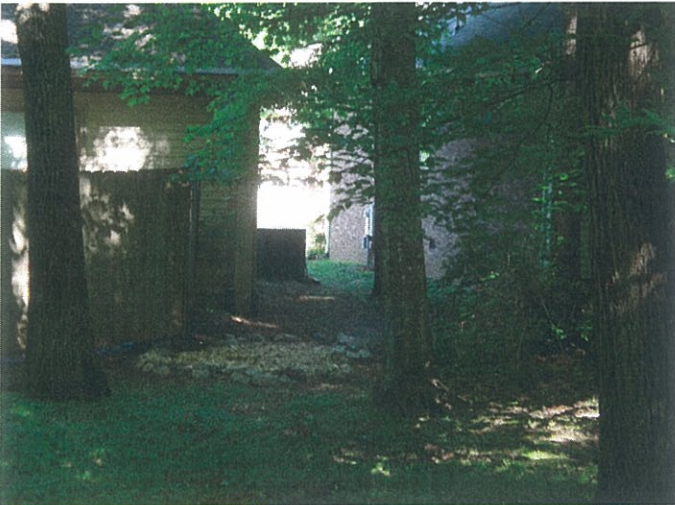
PHOTO NO. 2589

A fairly large wooded area with heavy tree cover on the adjacent property drains down into the backyard of this property. The backyard of the property is shown in photos 2585, 2588, and 2589. These photos show that the homeowner has constructed several small rock check dams in an attempt to slow down the flow of stormwater and stop erosion of their landscaped beds. Once the water comes down into the backyard, it flows around the side of the house, which is shown in photos 2587 and 2591. The adjacent lot at 2420 Devon Valley Drive has a drainage ditch in the rear that catches the upland runoff and conveys it to a headwall that is located two lots to the left. However, this ditch is too far up the hill to extend to provide any benefit. I recommend the following:

- All the area that is disturbed and re-graded with the construction of this ditch should be stabilized with vegetative ground cover or erosion control matting.
